ARMY ENGINEER DISTRICT LOUISVILLE KY GRAND LAKE SAINT MARYS, OHIO, SURVEY REPORT FOR FLOOD CONTROL A--ETC(U) AUG 81 AD-A112 108 UNCLASSIFIED NL 1.4.2

Survey Report for Flood Control and Allied Purposes

Volume 1 of 2 Main Report

ENGINEER DISTRICT, LOUISVILLE, KY.

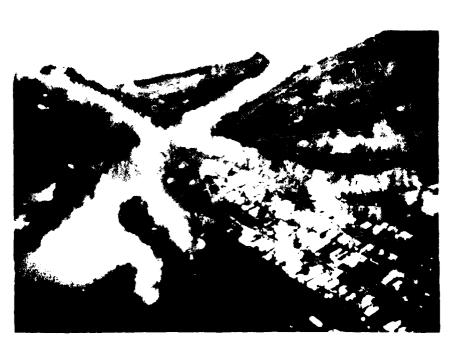
EXHIBIT NO. 10 Boat access channels requiring frequent maintenance dredging. (Dec. 1978)

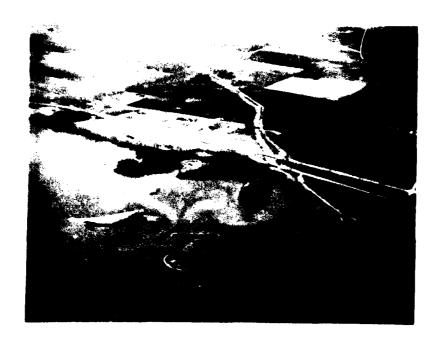
EXHIBIT NO. 27 Mouth of Coldwater Creek at southwest corner of lake.

Sediment input to the lake. (Dec. 1978)
